**Subject: Evaluation of Soil Gas Data Collected at the
Center for Women in Transition
Ameren Champaign MGP Site
State ID 0190100008**

**Evaluation of Soil Gas Data Collected at the
Center for Women in Transition**

**304 N. 5th St., 504, 506, and 508 E. Church St.
Champaign, Illinois**

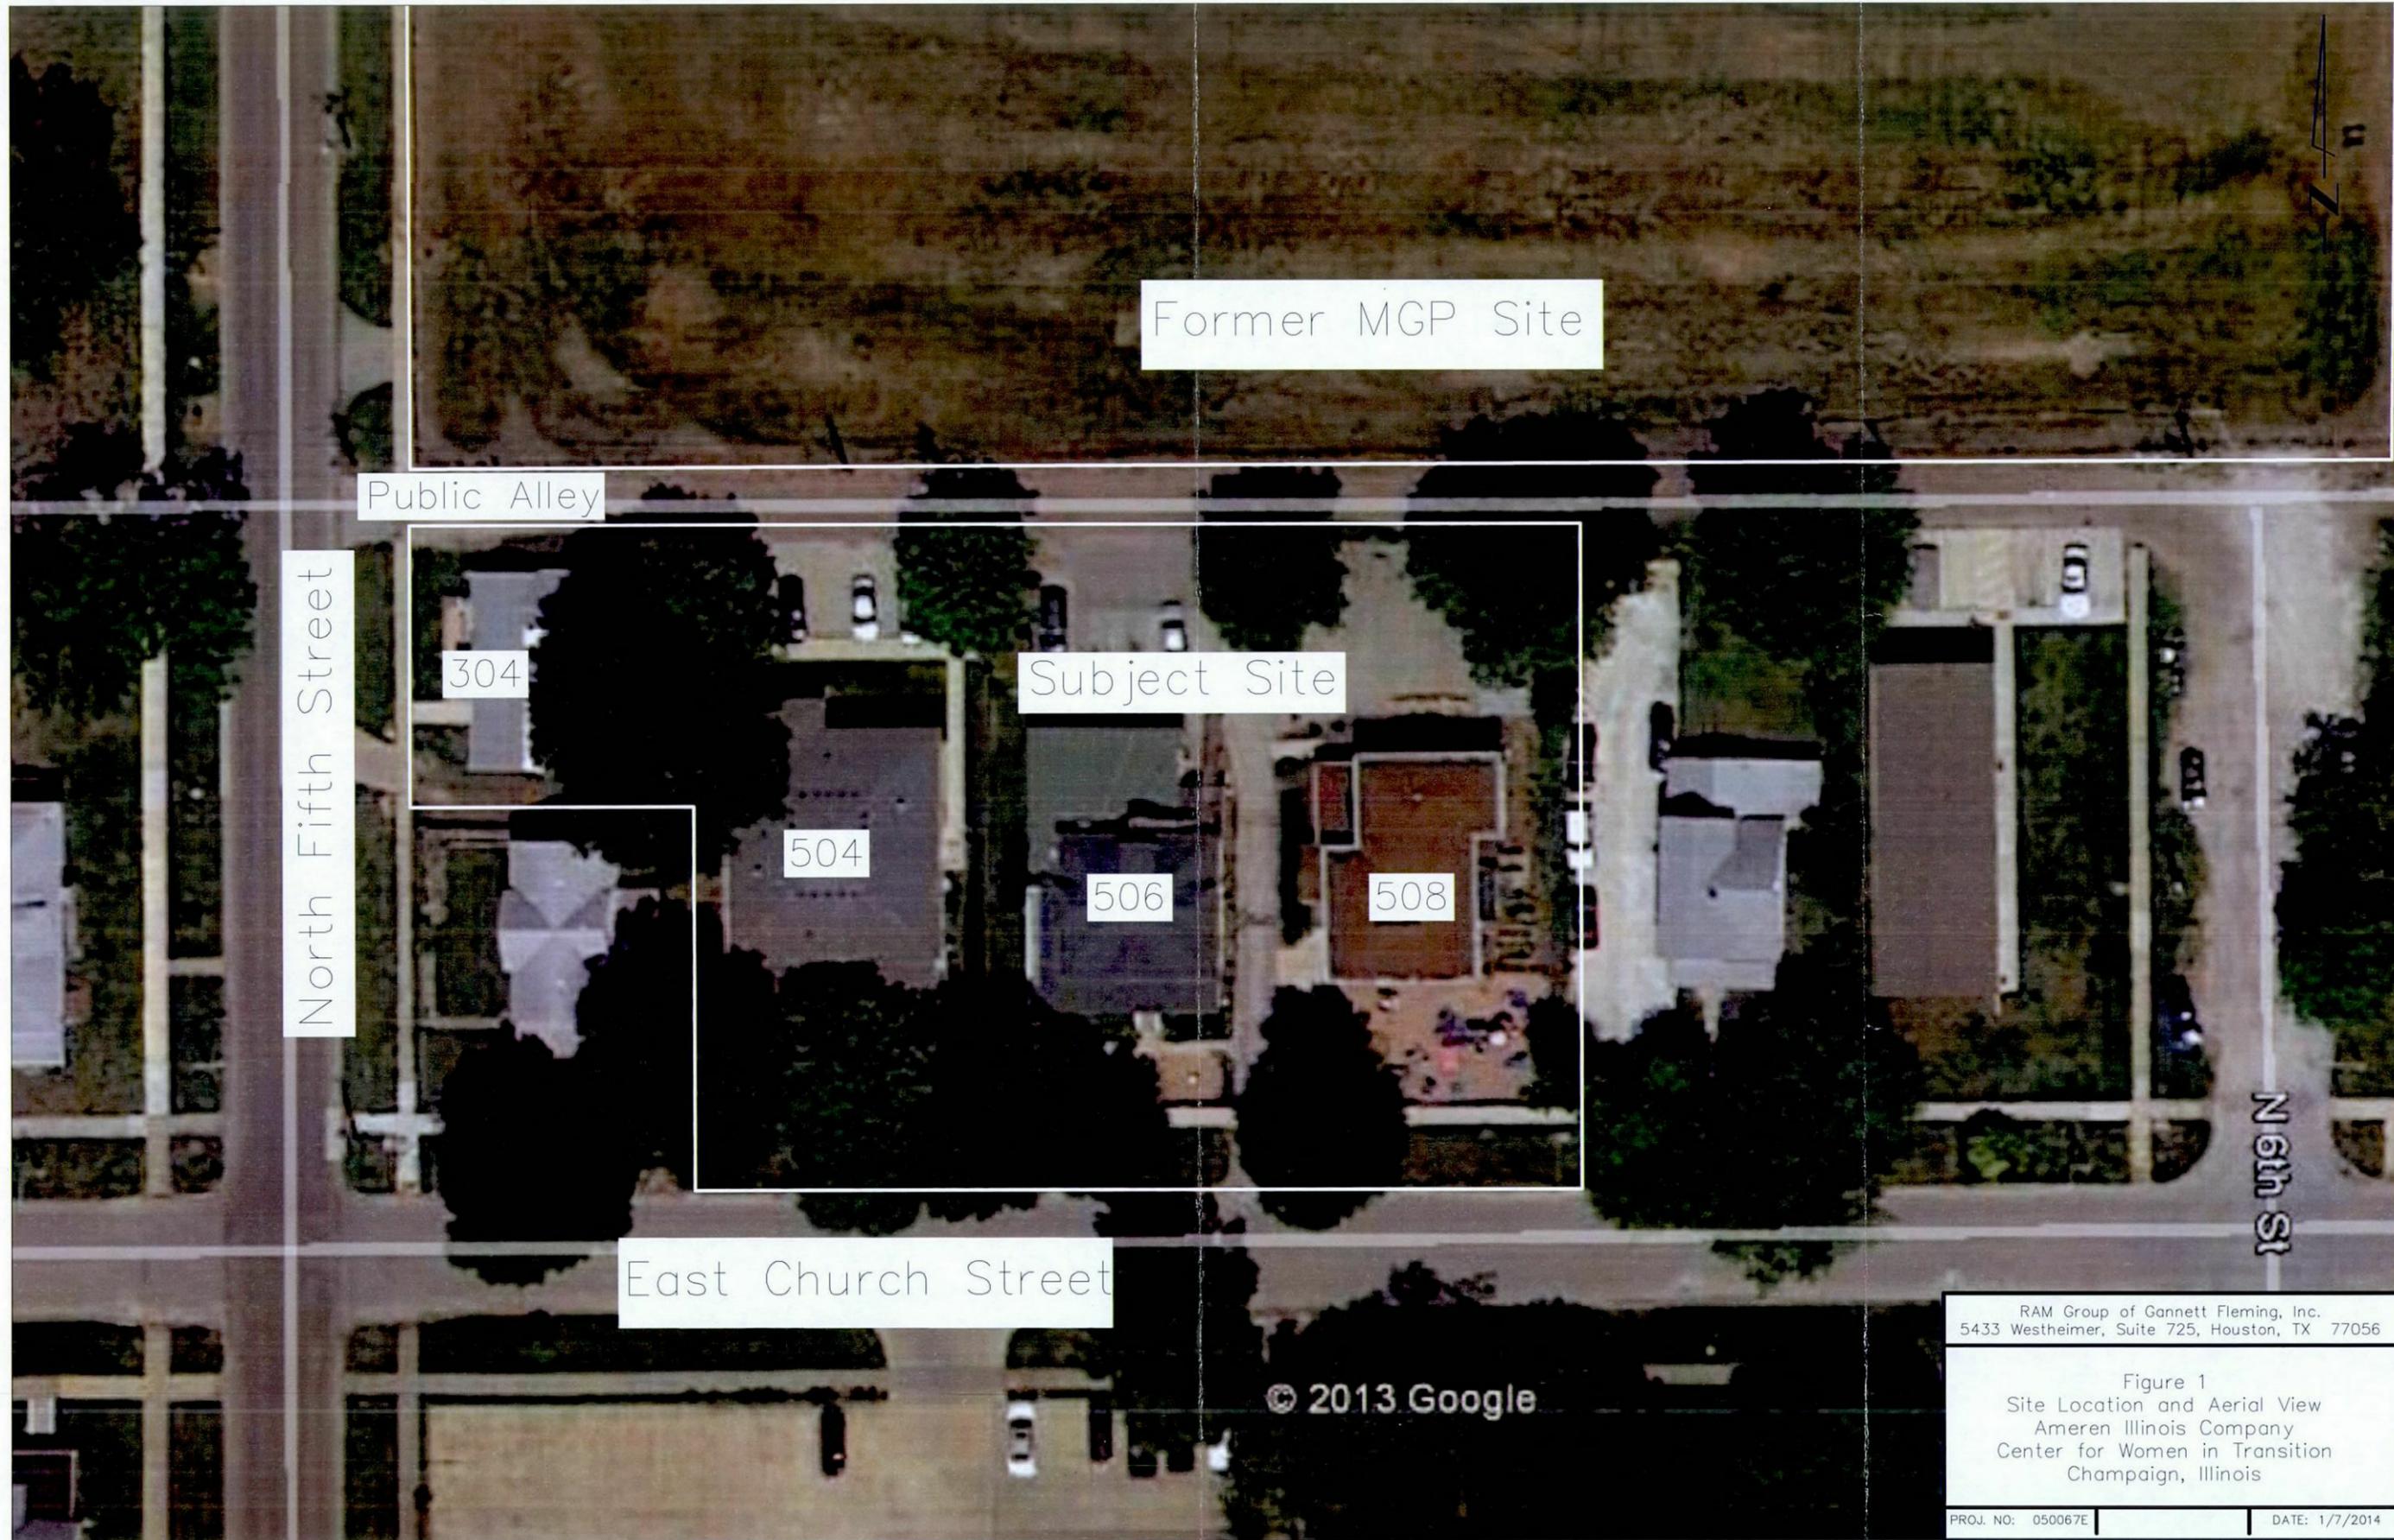
Figure 1 shows the locations of the four residential properties, former MGP site boundary, and nearby streets. The former MGP site is fenced and access is restricted by locked gates.

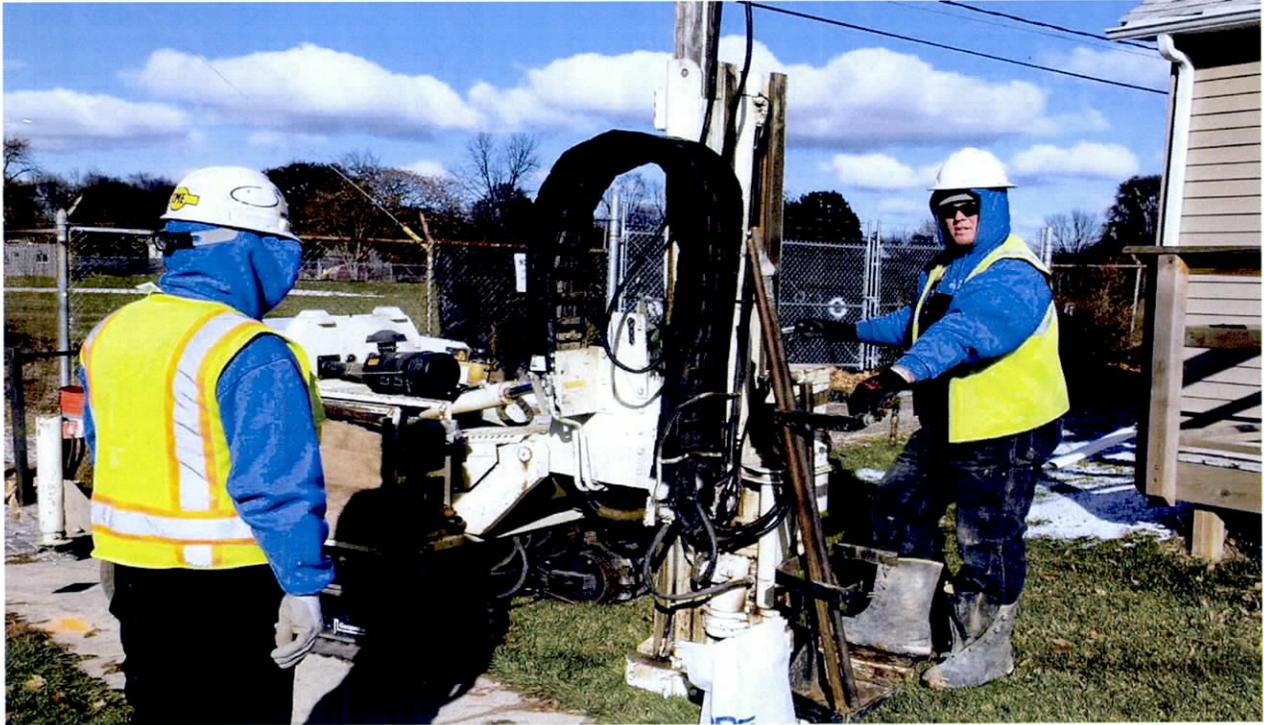
Photo 1: 304-W-1 Boring Installation Using Geoprobe 6610DT

The sampling involved the use of 1.25" diameter steel rods that were advanced vertically using a Geoprobe® 6610DT track-mounted rig by REDI. Care was taken to prevent damage to the properties. Hydrated bentonite was placed around the rods where they entered the ground to create a seal at the ground surface (e.g., see Photo 20 in Appendix B). Teflon® tubing was attached to the PRT adapter and pushed down inside the rods, seated, and threaded into an expendable point holder. Next, a Swagelok® three-way valve and a gas-tight 60-milliliter (mL) disposable syringe were connected to the Teflon® tubing (e.g., see Photos 16, 23, and 24 in Appendix B) and the steel rods were pulled up approximately 1 foot to dislodge the rods from the expendable point.

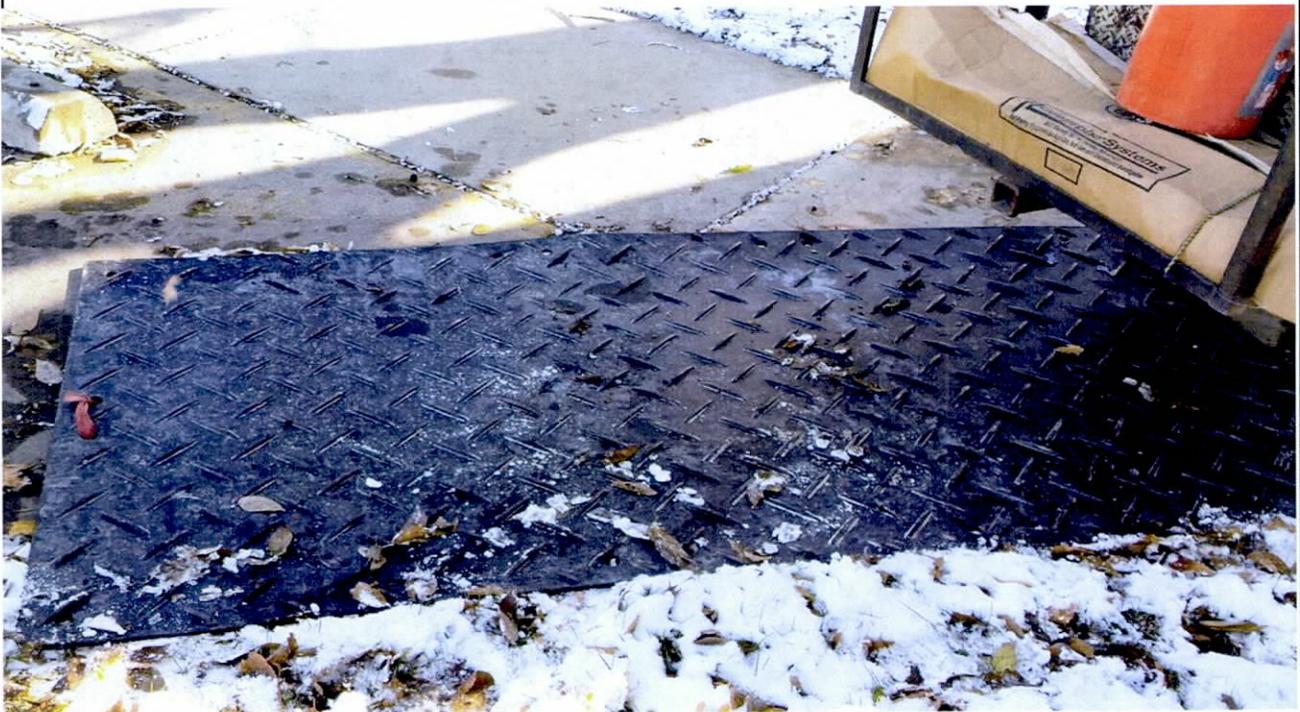
Photo 6: Mud Mats used at 304-E-3 to avoid damage to grass and pavement

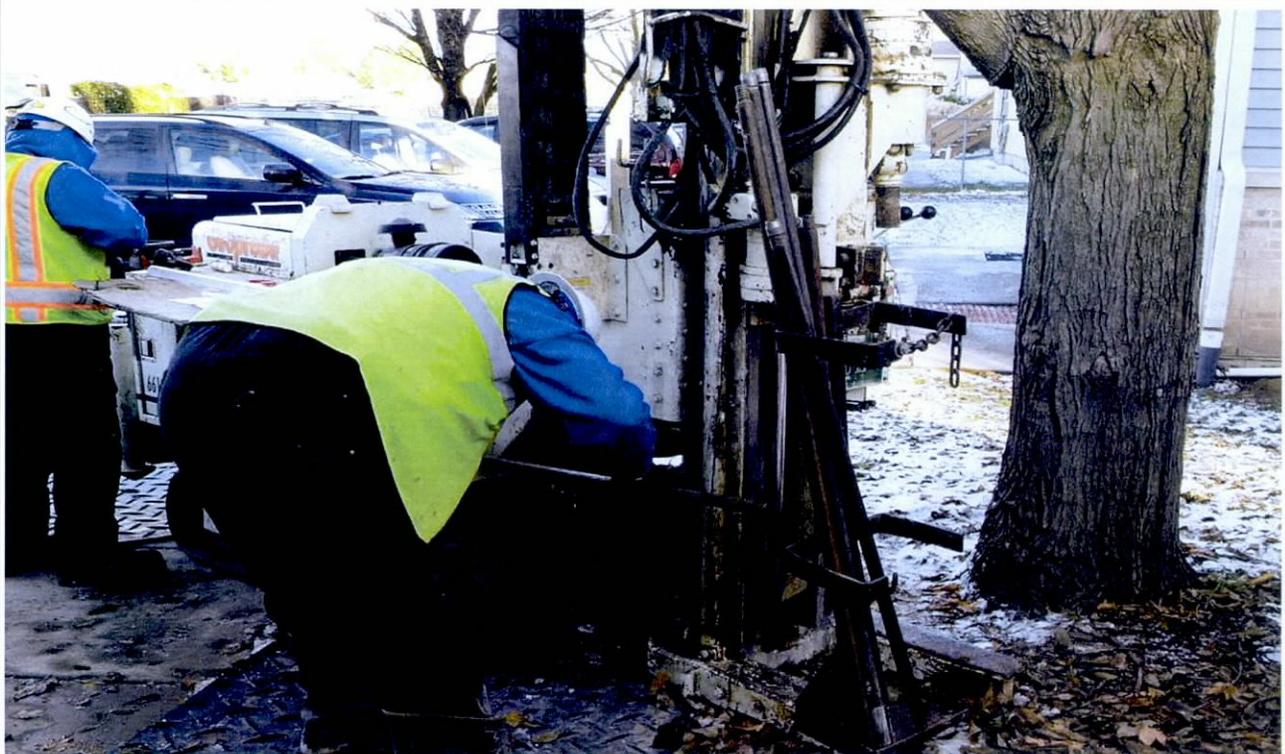
Photo 8: 304-E-GT-11 Geotech Soil Sampling

Two soil samples, 304-E-GT-11 and 506-E-GT-12, were collected at a depth of 4-8 and 3-7 feet, respectively in macro-core tubes using Geoprobe 6610DT rig for geotechnical parameter analysis (Figure 2). The samples were cut into two feet cores for ease of shipping and sent to PTS Laboratories in Santa Fe Springs, California. As per the work plan, the samples were placed on hold pending the results of the soil gas analysis. Since the soil gas sample results did not exceed target levels, the geotechnical samples were not analyzed.

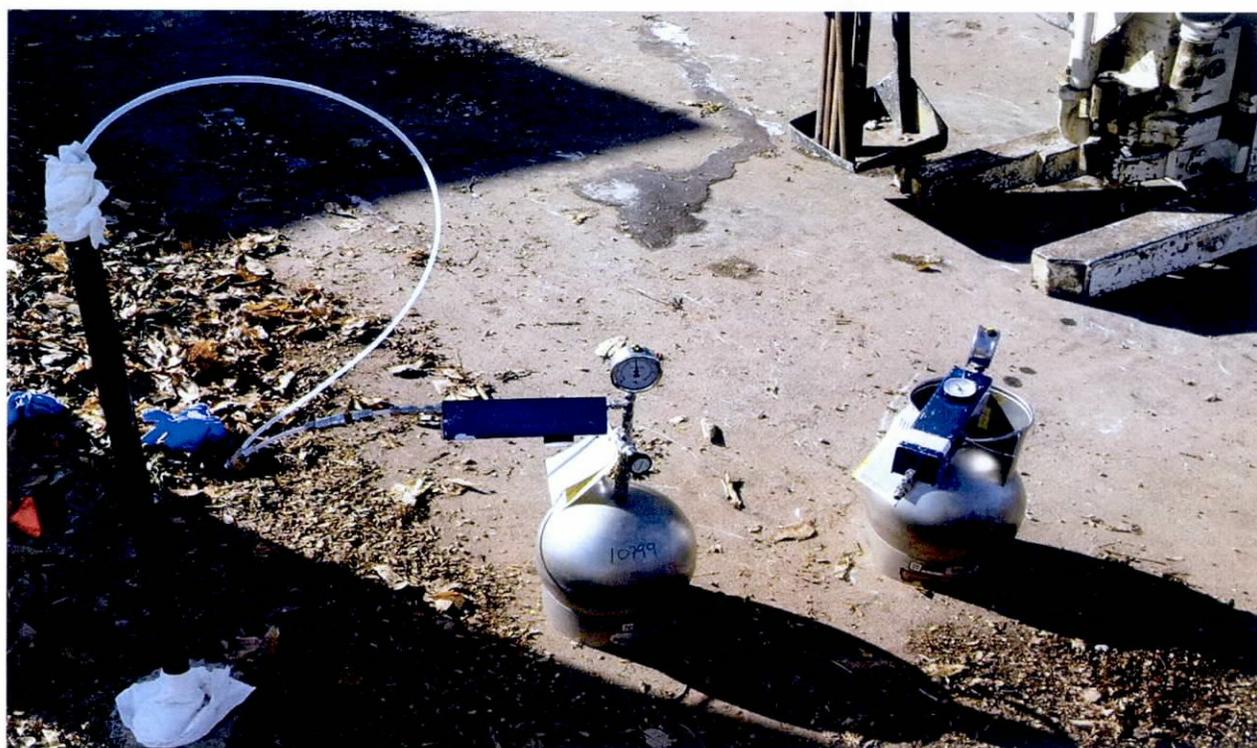
1,1-Difluoroethane was used as a leak detection compound to check for the presence of leaks in the sampling system (i.e., short-circuiting). Household paper towels, wetted with computer keyboard duster spray containing difluoroethane, were wrapped around the steel rods at the ground surface/bentonite seal (to test for short-circuiting at the borehole annulus) and around the top of the rod where the Teflon® tubing exited the steel rods to test for short-circuiting across the O-ring seal in the PRT adapter (e.g., see Photo 12 in Appendix B).

One ambient air sample was collected using a 6-liter canister simultaneously with the 504-N-12 soil gas sampling. The ambient air sample was collected by connecting the flow controller directly to the canister and opening the canister via the flow controller inlet to the outdoor air (see Photo 12 in Appendix B).

Photo 12: 504-N-12-Soil Vapor Sampling and Ambient Air Sampling

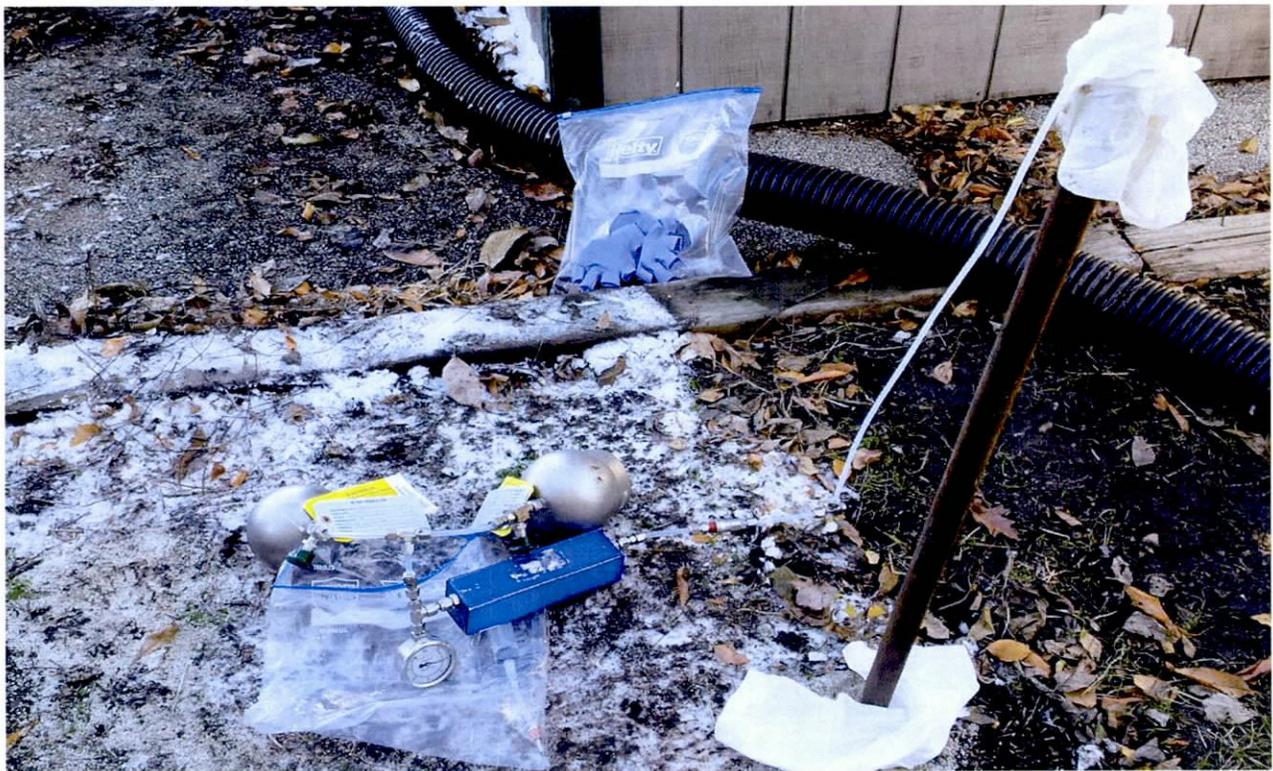
A field duplicate was collected at 508-N-9 using a sample splitter. Benzene was detected at 4.1 and 3.9 micrograms per cubic meter ($\mu\text{g}/\text{m}^3$) in the original and duplicate samples, respectively, with a relative percentage difference (RPD) of 5%. 1,1-Difluoroethane was detected at 4,900 and 3,900 $\mu\text{g}/\text{m}^3$ in the original and duplicate samples, respectively, with an RPD of 23%. The RPD of both detected chemicals is below the acceptable level of 25%. Toluene and m,p-xylene were detected in the duplicate sample (508-N-9D) at 11 and 7.8 $\mu\text{g}/\text{m}^3$ but were below detection in the original sample (508-N-9). However, the detected concentrations are less than 5 times the reporting limit which is an acceptable level per conversations with the laboratory. Therefore, there is no effect on data quality and overall results indicate the data is acceptable.

Photo 21: 508-N-9-Soil Vapor Sampling with Duplicate

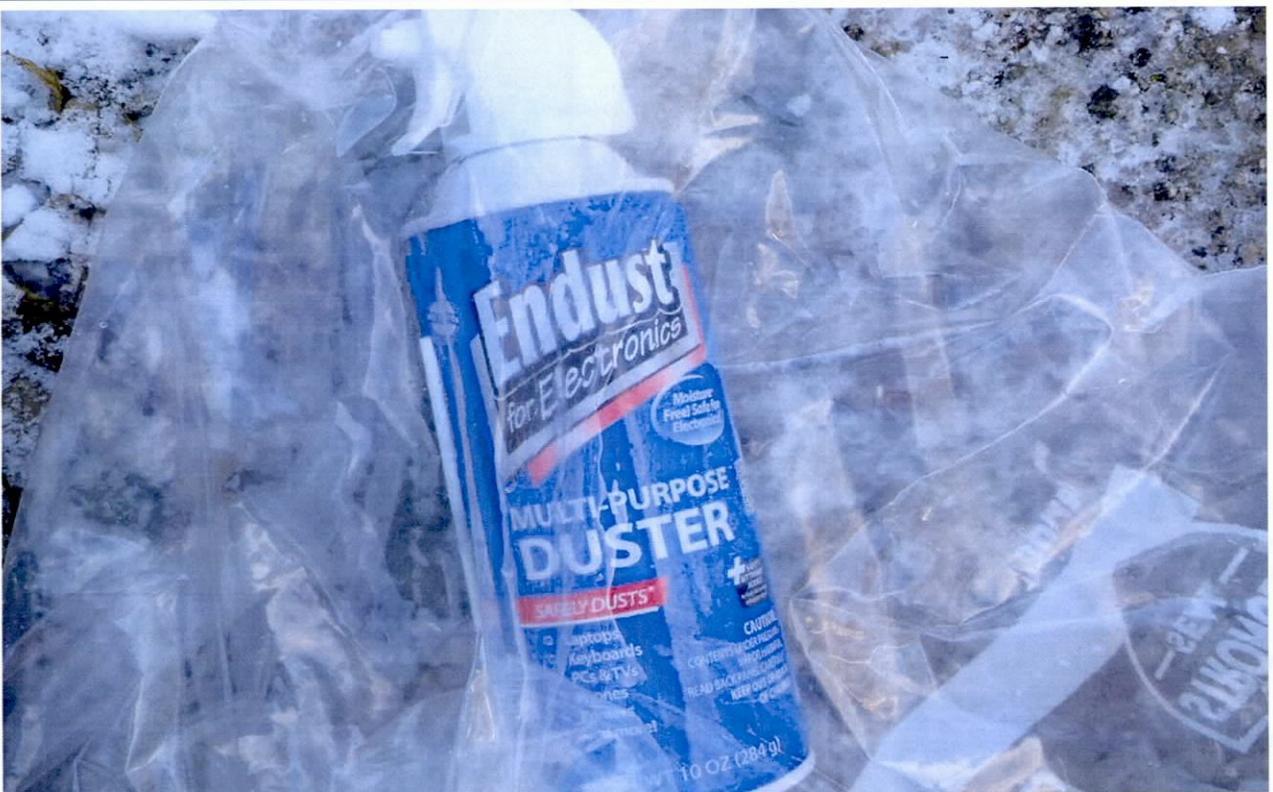
Photo 22: Leak Detection Compound (Duster Spray containing 1,1-Difluoroethane)

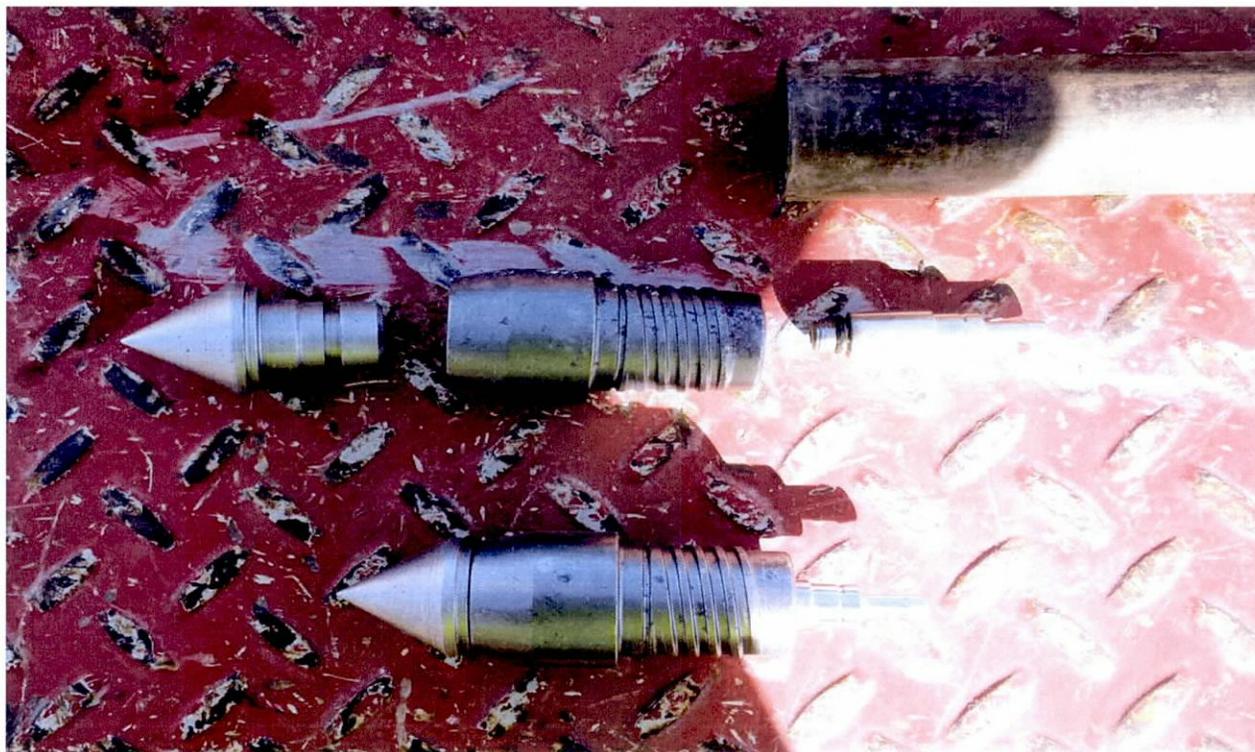
Eleven soil gas samples (including one duplicate) were collected from ten locations using Geoprobe® PRT sampling methods (Geoprobe, 2013). The depths used in the previous sampling event were used to collect soil gas samples. The probe rods were pulled up an extra foot to facilitate sample collection when tight soils were encountered. All the soil gas samples were collected at a depth of more than 3 ft bgs and above the shallow groundwater table. Specific sample depths are presented in Table 1. Groundwater was not encountered at any of the locations.

Photo 23: Post Run Tubing (PRT) Method Soil Vapor Sampling Assembly

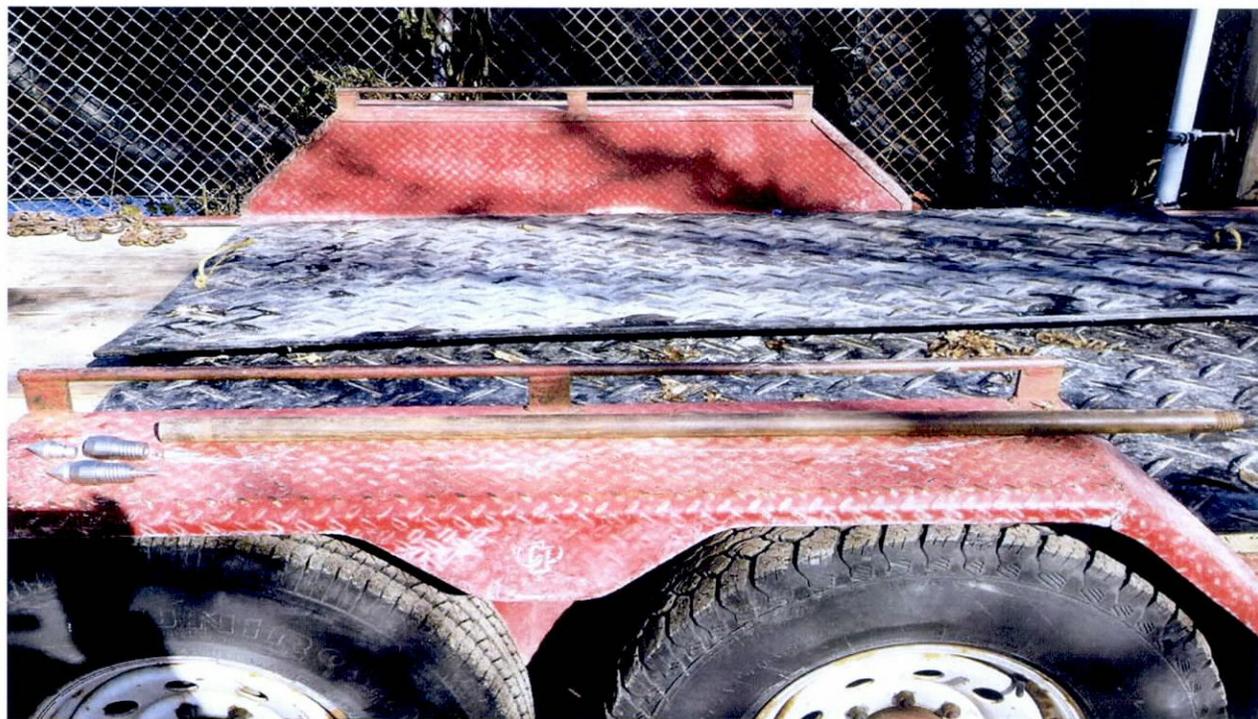
Photo 24: Post Run Tubing (PRT) Method Soil Vapor Sampling Assembly-2

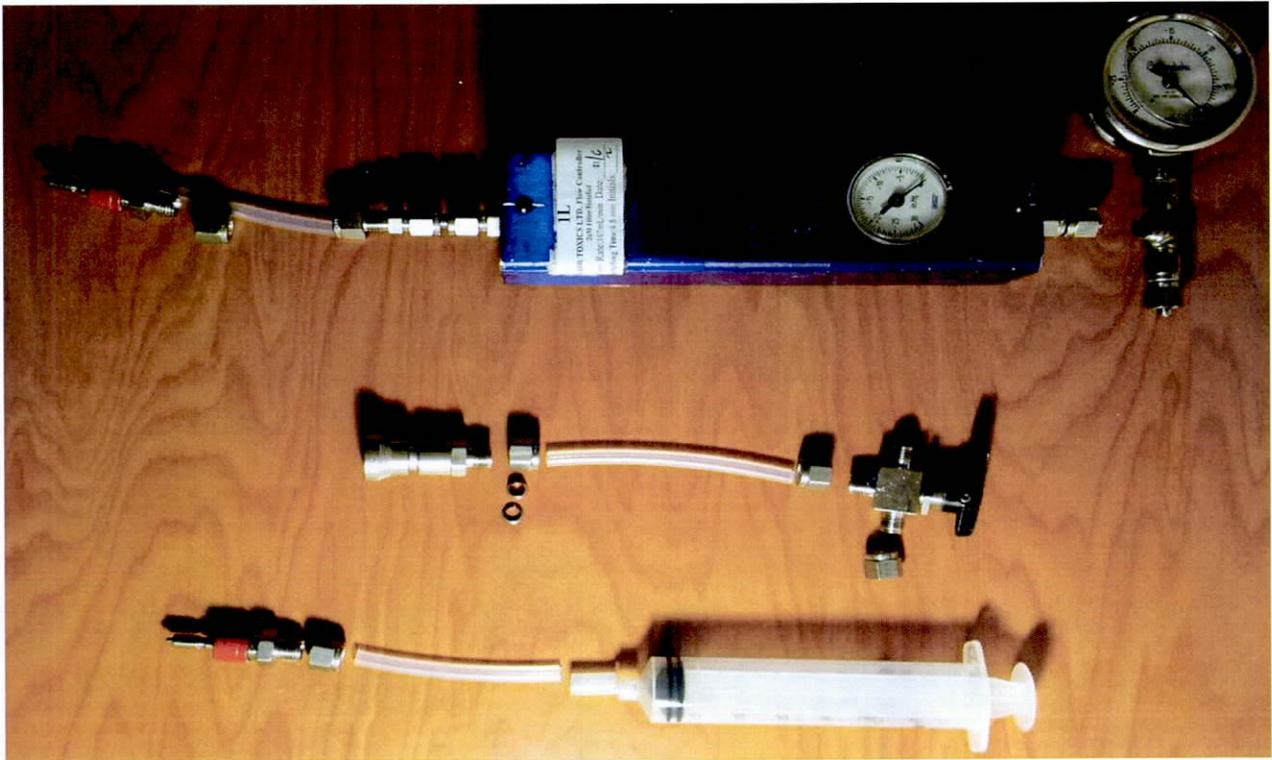
Photo 25: Soil Vapor Purging and Sampling Assembly

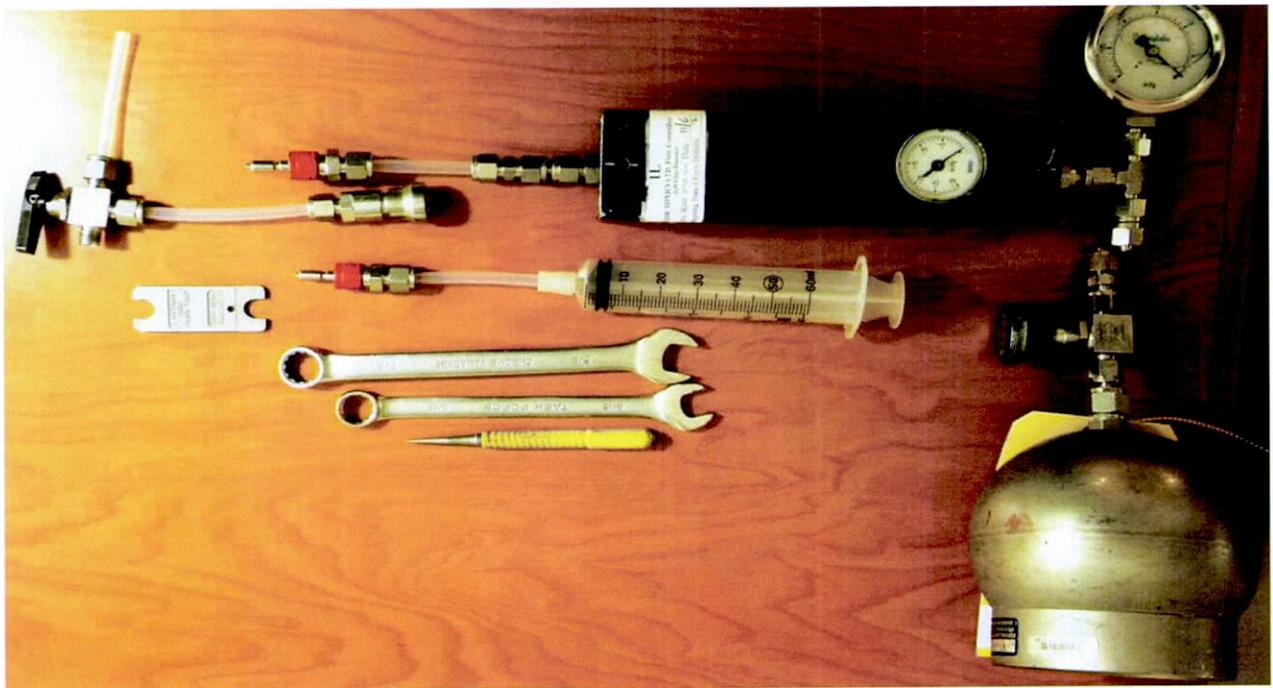
Soil gas samples were collected using 1-liter Summa canisters (process certified) except at 504-N-12 where a 6-liter canister was used due to shortage of canisters. Purge volume calculations were performed and the tubing was purged prior to sample collection using the Swagelok® three-way valve and 60-mL disposable syringe. Purge volumes are presented in Table 1 which ranged from 952 to 1756 mL. After purging, a Summa canister was connected to a flow controller set by the laboratory at 167 mL/min. The flow controller includes an internal filter to prevent solids from entering and to control the soil gas flow rate into the canister. The flow controller was then connected to the Swagelok® three-way valve for sample collection (e.g., see Photo 12 in Appendix B). For the duplicate sample, collected at 508-N-9, a sample splitter was used to allow soil gas to enter two canisters simultaneously using a single flow controller.

Photo 26: Soil Vapor Purging and Sampling Assembly with Summa Can
